**State of Louisiana
Department of Natural Resources
Coastal Engineering Division**

**2005/2006 Annual Inspection
Report**

**HUMBLE CANAL HYDROLOGIC
RESTORATION PROJECT
(ME-11)**

October 19, 2005
Cameron Parish

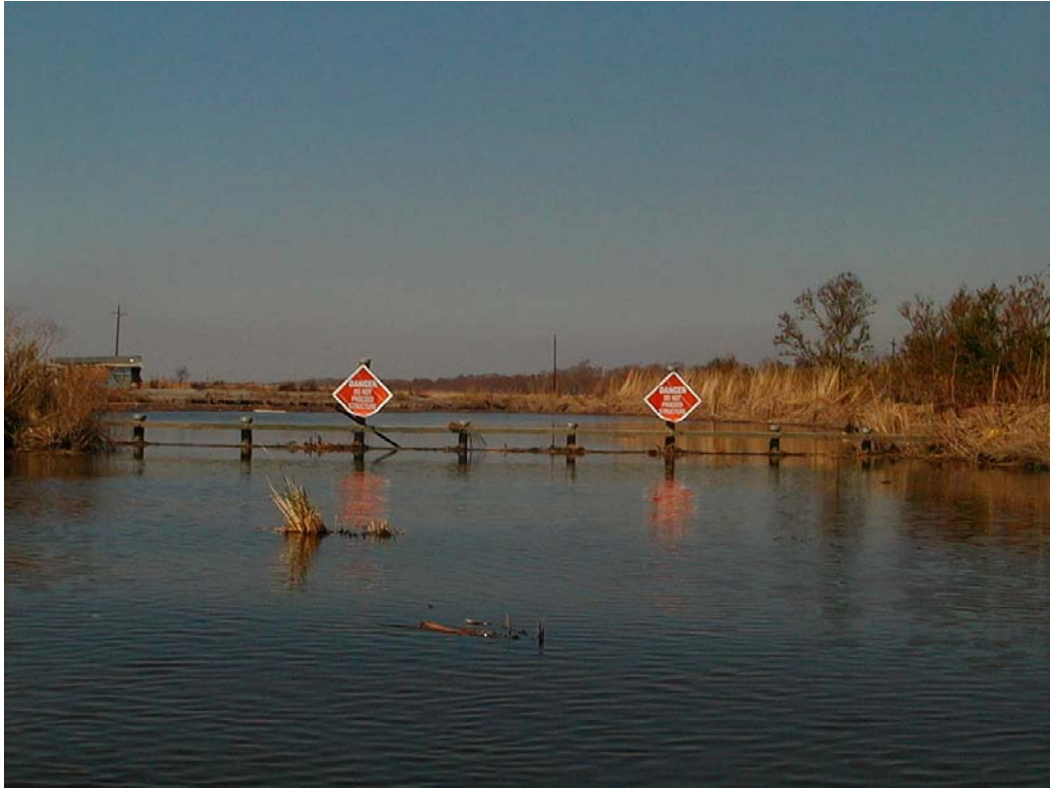
The structure is in excellent condition. Some shrinkage of the sign lettering has occurred and the signs are slightly bent from Hurricane RITA damage. Bank tie-ins, pile caps, hardware, etc. is in excellent condition. No maintenance is required at this time. (Photos: Appendix B, Photo 1)

Photo 1, Marine barrier with signage.

Item	Condition	Physical Damage	Corrosion	Photo #	Observations and Remarks
Steel Bulkhead / Caps	good				
Steel Grating					
Stop Logs	N/A				
Hardware	good				
Timber Piles	good				
Timber Wales	good				
Galv. Pile Caps	good				
Cables	N/A				
Signage / Supports	good			1	Some odd shrinkage of the lettering on the warning signs. Still no cause for concern. Signs slightly bent from Hurricane RITA damage.
Rip Rap (fill)	N/A				
Eathern Embankment	N/A

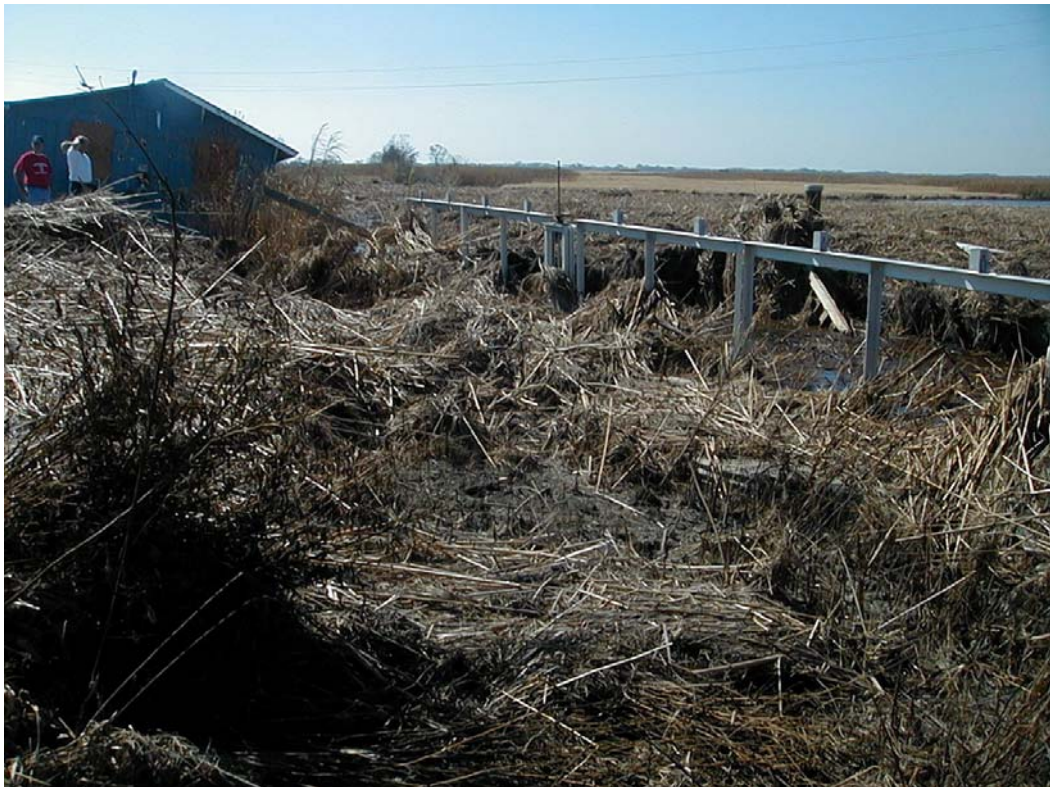
This feature is in good condition. There is a large amount of debris and wrack material clogging the hyacinth guard. Maintenance is required at this time. (Photos: Appendix B, Photo 2)

Photo 2, Inlet side showing hyacinth fence in background covered with debris, as well as embankment of structure.

Item	Condition	Physical Damage	Corrosion	Photo #	Observations and Remarks
Steel Bulkhead / Caps	good				
Steel Grating	N/A				
Stop Logs	N/A				
Hardware	fair			2	Hyacinth fence is covered with wrack and debris.
Timber Piles	good				
Timber Wales	good				
Galv. Pile Caps	good				
Cables	N/A				
Signage /Supports	N/A				
Rip Rap (fill)	N/A				
Earthen Embankment	N/A

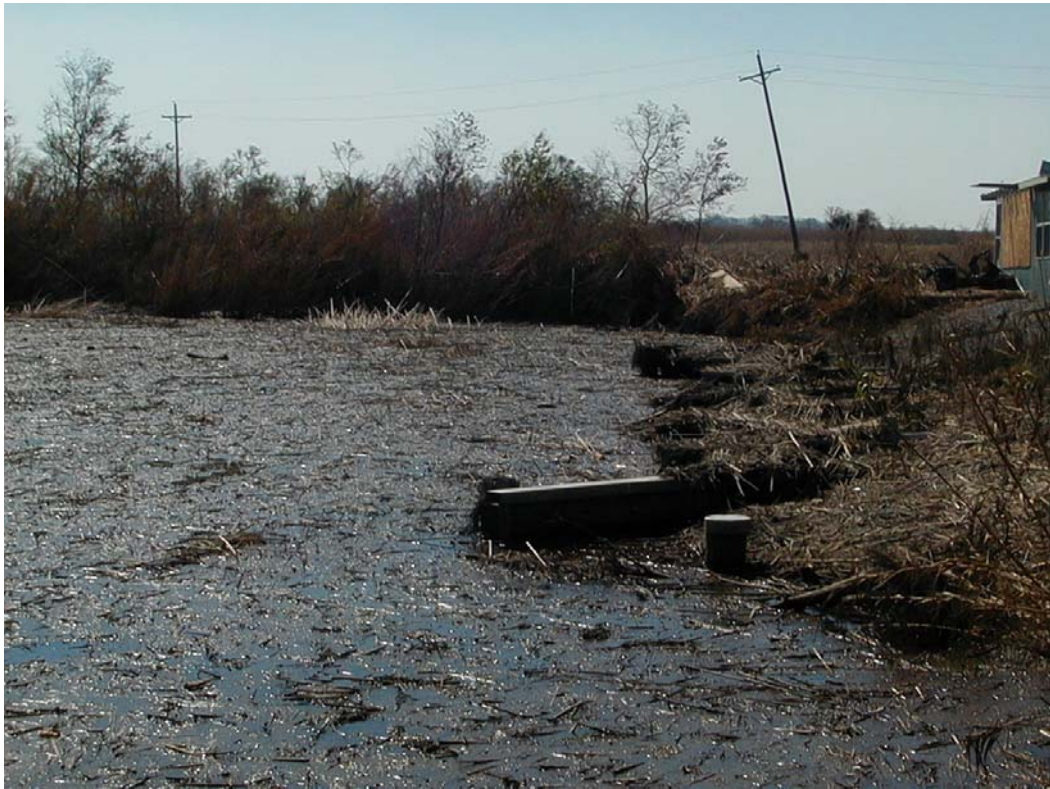
Overall, the structure is in good post construction condition. The inspection noted erosion of the embankment behind each wing wall and over the structure along with an extensive amount of wrack clogging the inlet channel which is affecting flow through the structure. A nearby camp building has been deposited on the southern portion of the structure from Hurricane RITA storm surge, however it is not impacting the operation of the structure. Maintenance will be required at this time. Both agencies agreed to perform a structural assessment survey in 2006/2007 for comparison to previous as-built surveys. (Photos: Appendix B, Photos 3, 4 & 5)

Photo 3, Outlet side of structure covered with wrack.

06/07 Description: Maintenance event to clean inlet channel,repair rock embankment (damages from Hurricane RITA)

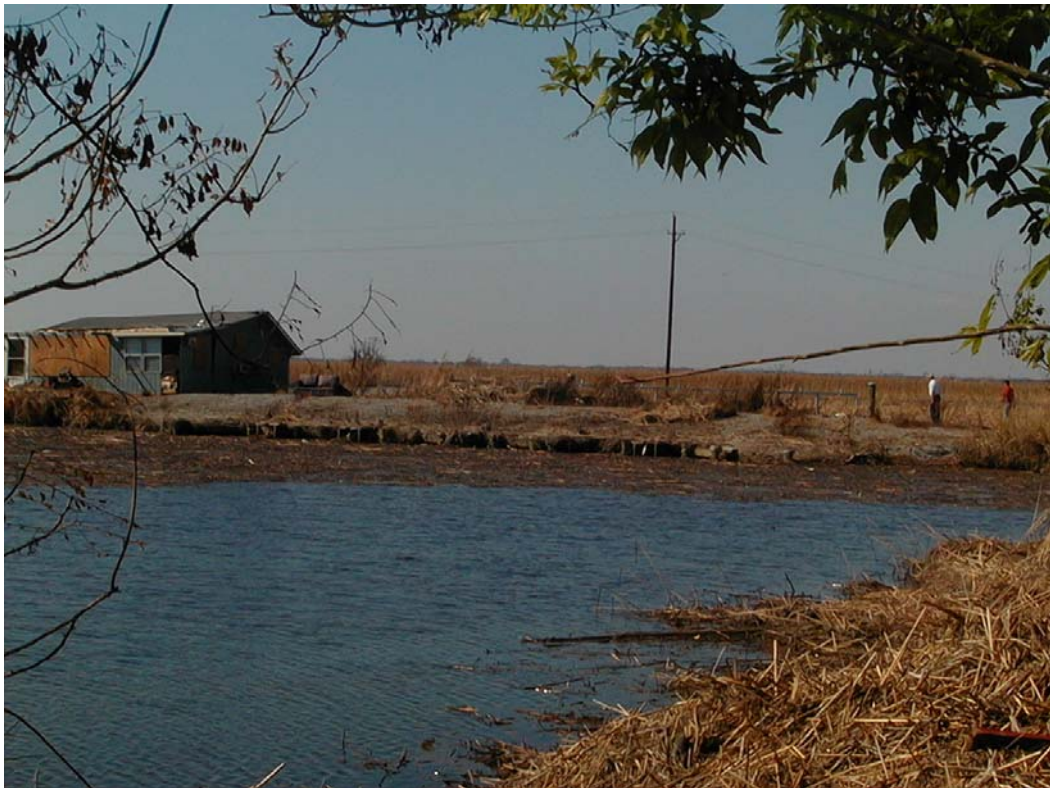
Photo 4, Showing camp on southern end of structure embankment.

Overall, the Humble Canal Hydrologic Restoration Project is in good condition however it is not functioning as designed due to the clogged inlet channel. The aluminum stoplog design that was used on this project appears to be easy to operate, light, and should have a long maintenance free lifespan. A maintenance event is planned to clean the wrack and debris from the inlet channel to restore flow and repair the embankment around the structure with stone. Repairs are also necessary on some of the flap gates and lifting arms. A FEMA claim has been submitted for repair of the structure. A structural assessment survey is recommended as noted above for fiscal year 2006/2007. Ownership of the camp will try to be determined and a decision made about final disposition of this building.

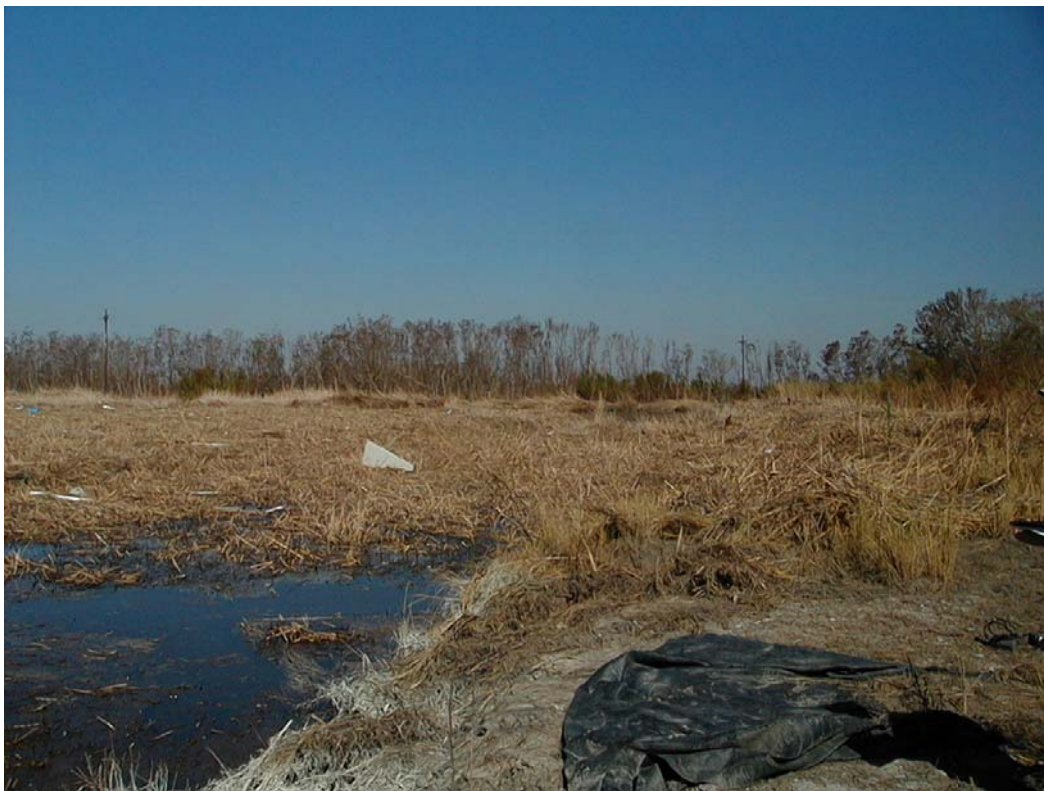
Photo 5, Showing clogged inlet channel, view looking north.

Item	Condition	Pysical Damage	Corrosion	Photo #	Observations and Remarks
Steel Bulkhead / Caps	good				
Steel Grating	good				
Stop Logs	good				Stoplogs on this structure are made of aluminum and should last practically forever.
Hardware	good				
Timber Piles	good				
Timber Wales	good				
Galv. Pile Caps	good				
Cables/ lifting device	good				The lifting apparatus was not on site.
Signage /Supports	good				
Rip Rap (fill) (foreshore dike)	good				
Eathern Embankment	fair			3	Erosion has occurred behind each wingwall and over the structure.
Inlet Channel/Plug				4	A camp building has been deposited on the southern end of the structure.
				5 & 6	Inlet channel completely clogged with wrack and debris, earthen plug removed by Cameron Parish GDD.

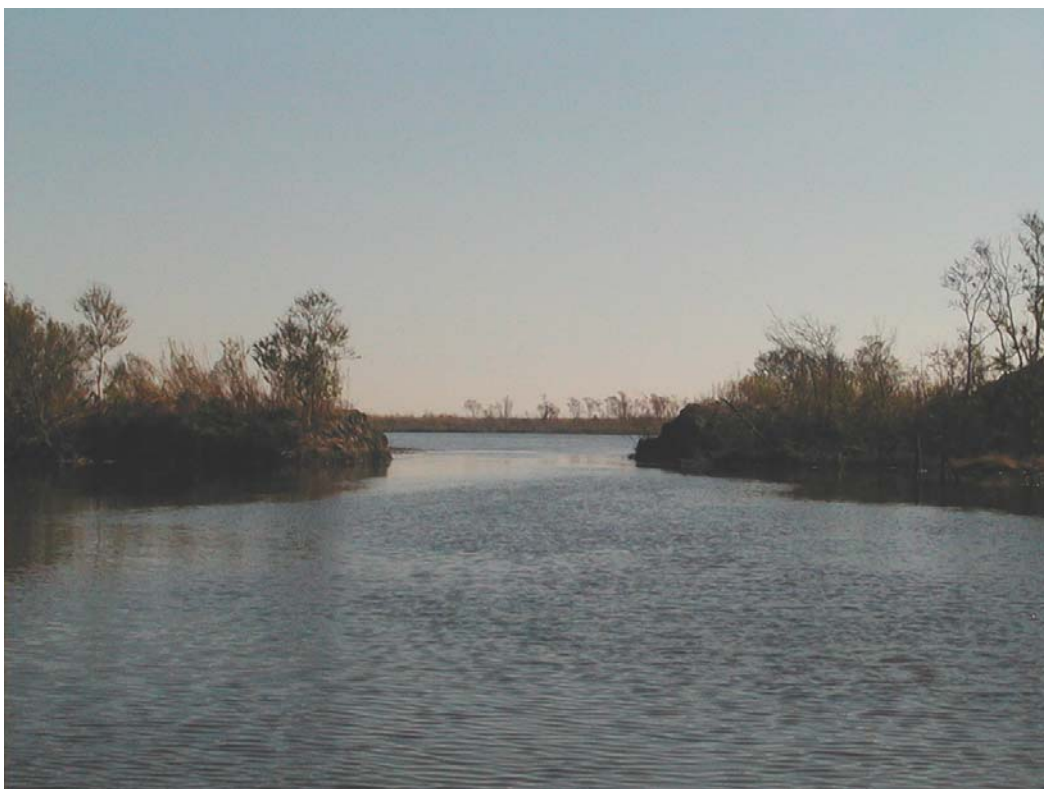
The earthen plug from the original Humble Canal was removed by Cameron Parish Gravity District to relieve high water levels from the storm surge of Hurricane RITA. (Photos: Appendix B, Photo 6)

Photo 6, Earthen plugged removed by Cameron Parish Gravity District to relieve high water levels.
